CALIFORNIA DIVISION OF MINES AND GEOLOGY

FAULT EVALUATION REPORT FER-110

March 15, 1981

Calaveras, Pleasanton and Sherburne Hills faults (Diablo quadrangle)

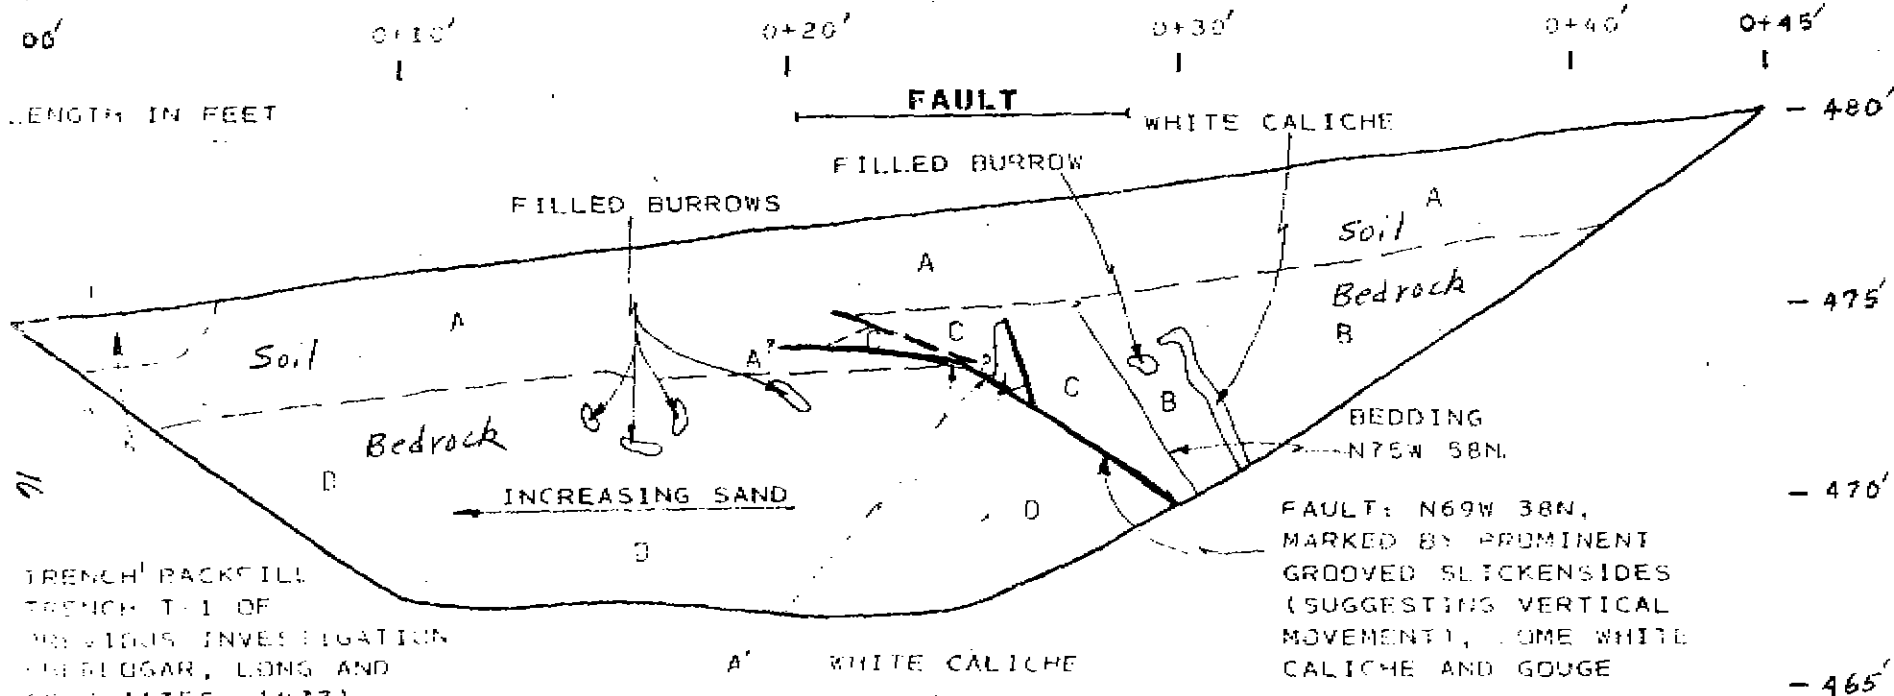
Just north of Watson Canyon, trench investigations of Berloger, Long (1979; C-422) indicate that the previously discussed fault extends  $N70^{\circ}W$  and is a north dipping thrust. Two trenches exposed bedrock to be thrust over soil by two to four feet. (Figure 5). Two other trenches on trend also reveal north east dipping faults, but the soil is not clearly offset. Landslides were identified uphill from the fault.

Figure 5 (FER-110). Log of Trench exposing offset soil along Picasanton fault at mouth of Watson Canyon, investigative site C-422 (after Berloger, Long & Assoc, 1979).

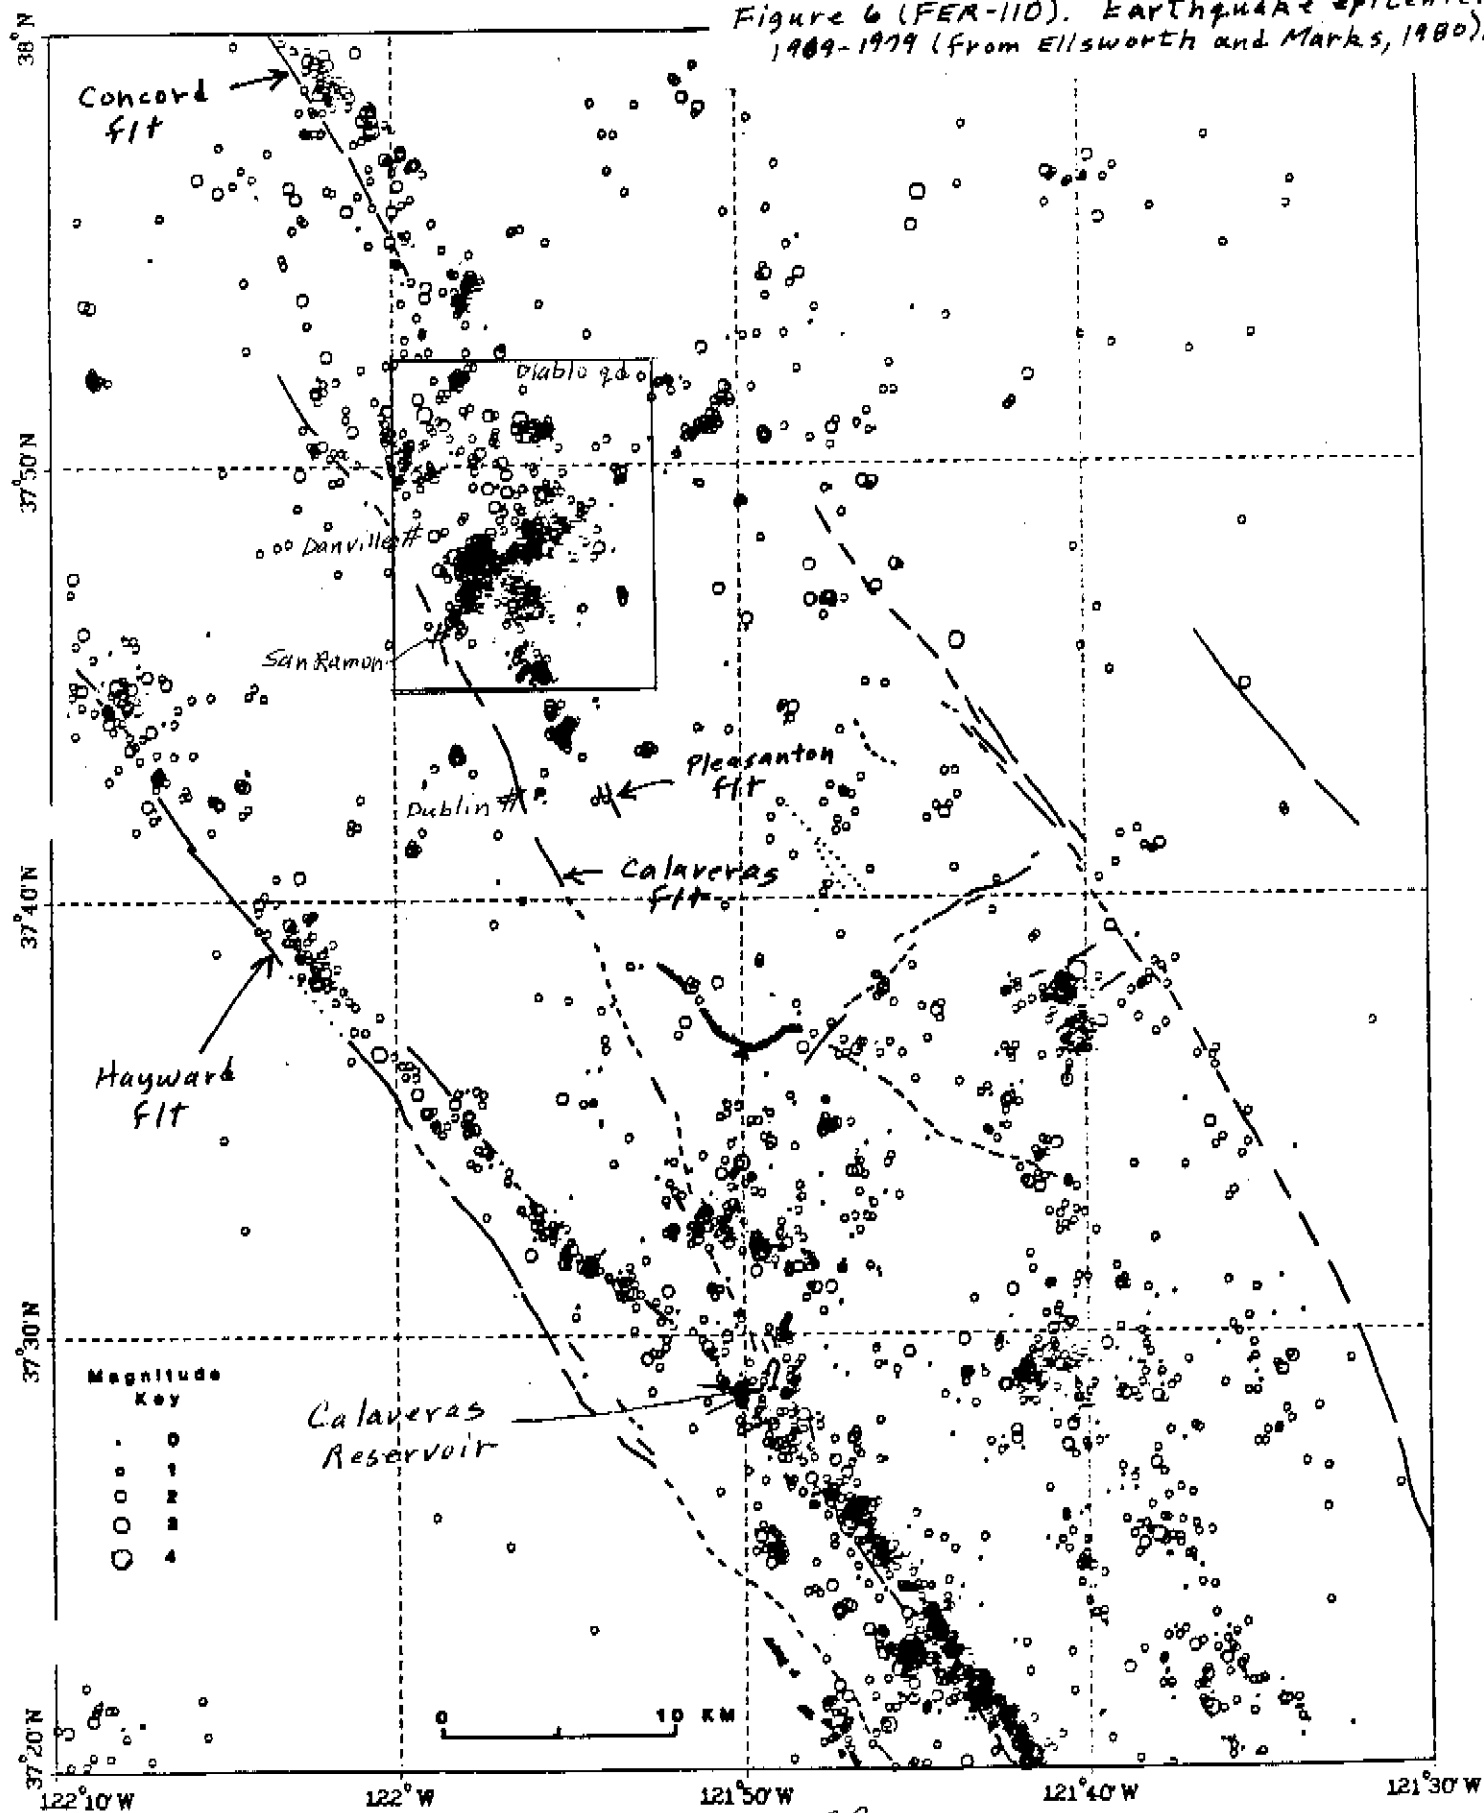
Figure 6 (FER-110). Earthquake epicenters 1969-1979 (from Ellsworth and Marks, 1980).

confidence in the epicenter locations. The zone of epicenters two <sup>to</sup> three km east of the Calaveras fault may be mislocated or the fault may dip steeply to the east. Alternately, this zone of epicenters may represent a north-west projection of the inferred Pleasanton fault. The first alternative is preferred by this writer, because focal mechanisms reportedly are "suitably oriented for right-lateral slip" (Ellsworth and Marks, p. 15) and the only <sup>significant</sup> active right-lateral fault mappable is the Calaveras fault (Figure 4).
